# Manhole Inspection Summary

Manhole # S13II2002MH

**Location** Address: **2110 SAREVA DR**

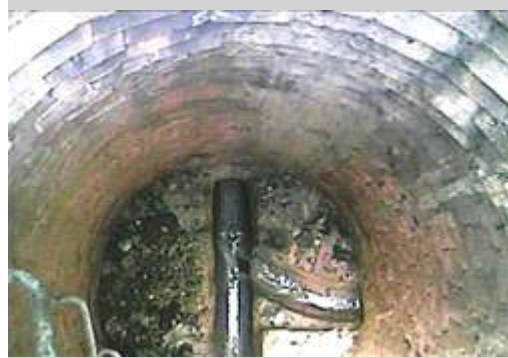
Top View

Barrel deterioration and infiltration. Bench debris.

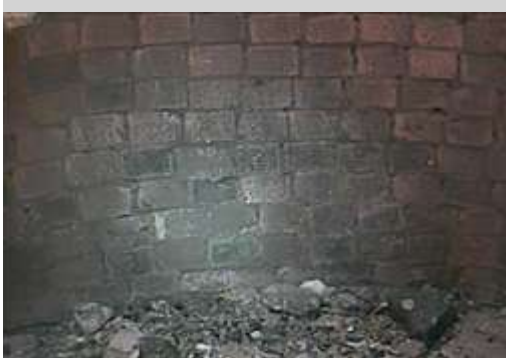
Defect

Barrel infiltration.

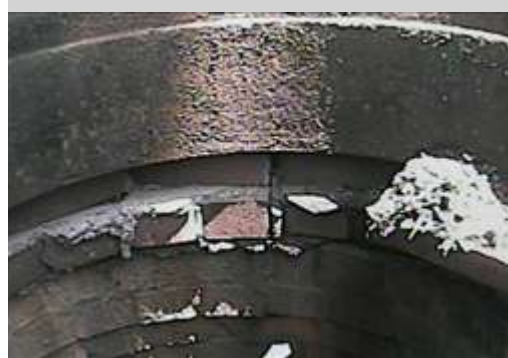
Defect

Frame leaks. Adjustment deterioration, root intrusion, and infiltration. Corbel infiltration.

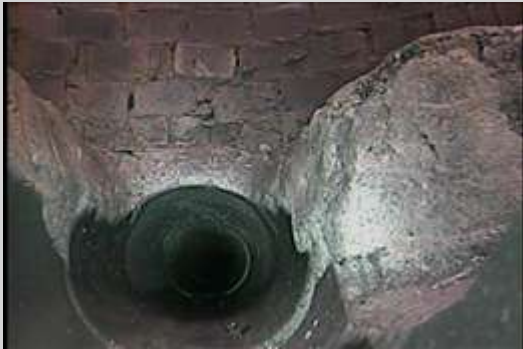
### 8 in. Circular Gravity Sewer Pipe Out @ 12 O'Clock

Infiltration: **Evidence** Pipe Seal Cond: **Unknown**

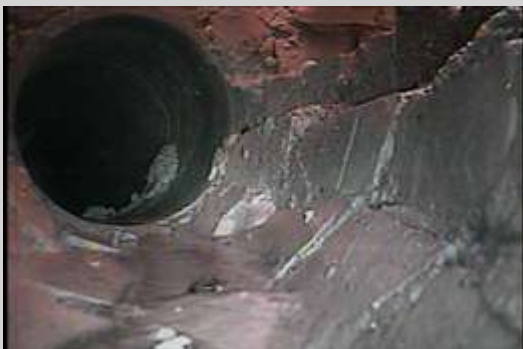
### 8 in. Circular Gravity Sewer Pipe In @ 3 O'Clock

Infiltration: **Evidence** Pipe Seal Cond: **Unknown**

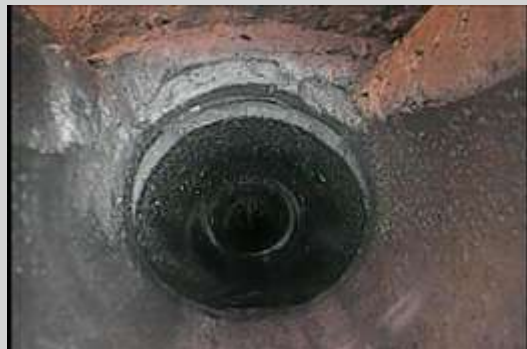
Pipe In @ 6 O'Clock

Infiltration: **Evidence**
